# Point Cloud-Based and Multi-Source Data Fusion for Monitoring the State of Conservation of the Defensive Walls of the Historic Town of Mértola, Portugal

**Abstract** – This paper presents a multi-source point cloud fusion methodology for the three-dimensional documentation and conservation state monitoring of the defensive walls of the Historic Town of Mértola, Portugal. Two Terrestrial Laser Scanner (TLS) campaigns conducted with a 5-month interval were compared to detect and map structural displacements along a critical wall section. A partial wall collapse recorded in the winter of 2025 was documented through a UAV photographic survey of the area. The resulting point cloud was then compared with the post-repair TLS dataset to quantify the volume of lost material, demonstrating the value of point-cloud methods for assessing damage in historic masonry. Geometrically complete point cloud representations of two wall sections were generated by integrating TLS, UAV photogrammetry and 360° spherical imagery, overcoming the geometric limitations of each individual technique. Additionally, a controlled metrological experiment using a test object of known geometry is presented to chara

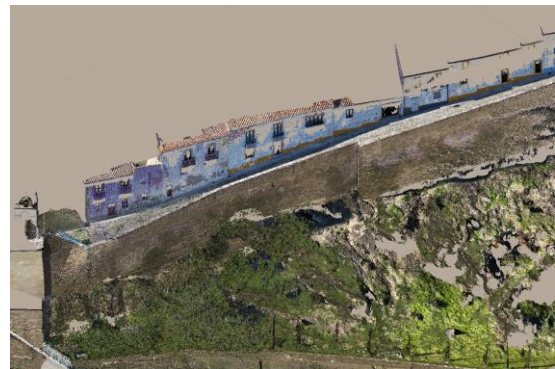
The multi-source fusion of TLS, UAV and spherical imagery produced geometrically complete point cloud representations of both the CTM (Fig. 3) and WW (Fig. 4) wall sections. TLS provided the primary geometric representation of the vertical masonry surfaces, while UAV photogrammetry complemented the dataset by capturing upper and otherwise inaccessible surfaces. For the WW section, 360° spherical imagery further complemented the reconstruction in areas where vegetation and terrain constraints prevented suitable TLS stationing and limited UAV coverage. The integration of these complementary datasets significantly improved the spatial completeness of the final models, particularly in occluded areas.

Fig. 3 Multi-source point cloud representation of the CTM section, integrating TLS and UAV photogrammetry.
